## FROM DISASTER TO DELIGHT

JIM EGAN

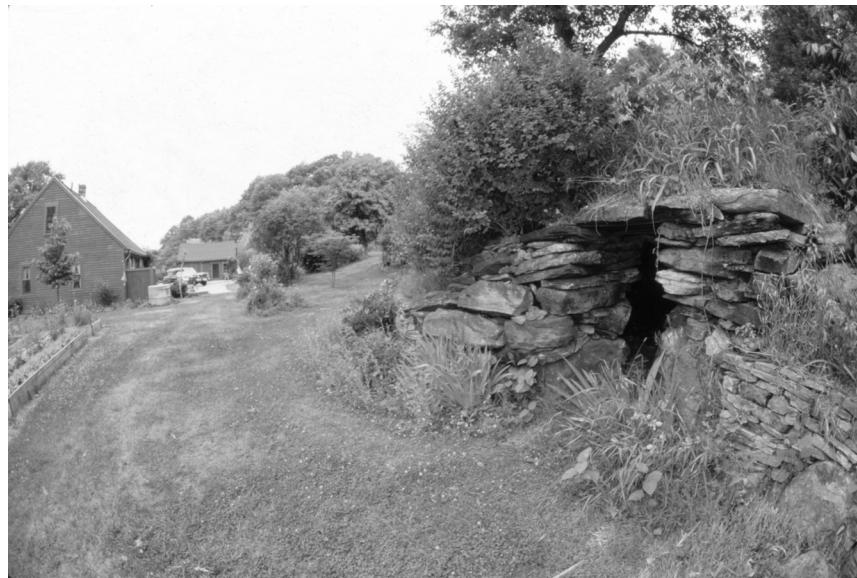
**FIGURE 1.** FRENCH RIVER CHAMBER, SUMMER 1987.

When I first visited the French River Chamber in North Grosvenordale, Connecticut (**FIGURE 1**) during the summer of 1984, there were indications that its structural integrity had been deteriorating for a while. In the process of excavating for the foundations of a nearby condominium development, dynamite had been used.

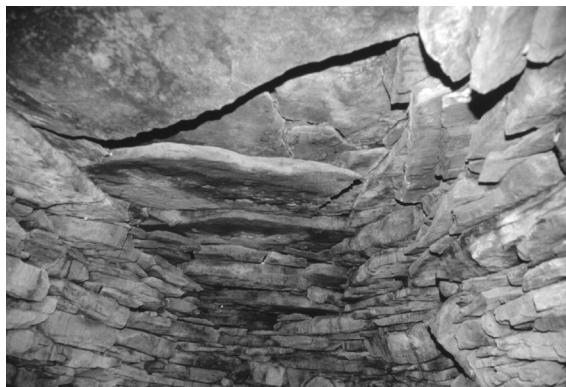
The vibrations had weakened the chamber's sidewalls, shifted the capstones, and cracked the lintel above the entry (**FIGURE 2**).

**FIGURE 2.** CRACKED CAPSTONES.

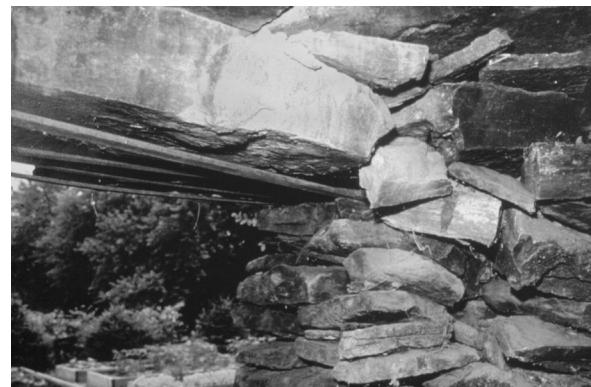
**FIGURE 3.** IRON RODS SUPPORT BROKEN LINTEL.

With the owner's permission, I reinforced the sagging lintel with 5 iron supporting bars (**FIGURE 3**). To insure that neighborhood kids wouldn't endanger themselves, the owner installed a wooden frame and doorway to secure the entryway.

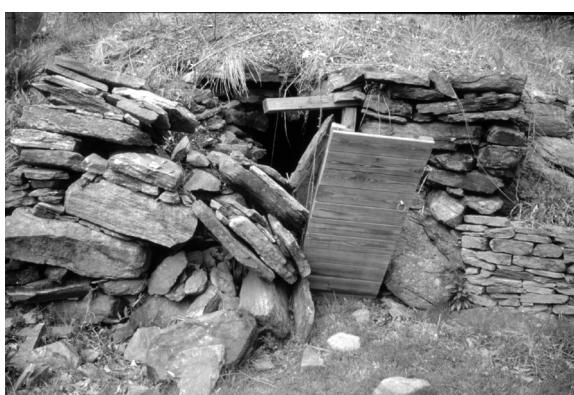
**FIGURE 4.** NEARA FIELD TRIP DISASTER, SPRING 1997.

The 1997 NEARA spring meeting was held in nearby Woodstock, Connecticut. The owner gave me permission to show this classic, oval-shaped, drywall chamber as part of our traditional Sunday field trip. Approximately 30 fellow members gathered around as I opened the door. Unbeknownst to me, the broken lintel had sagged more and was only being supported by the door and frame. Creak, crack, crunch!

As the door opened, the two lintel halves plummeted to the ground and the entire left supporting wall crumbled to my feet (**FIGURE 4**). I turned to see the crowd gasping in unison. It was truly a preservationist's nightmare.

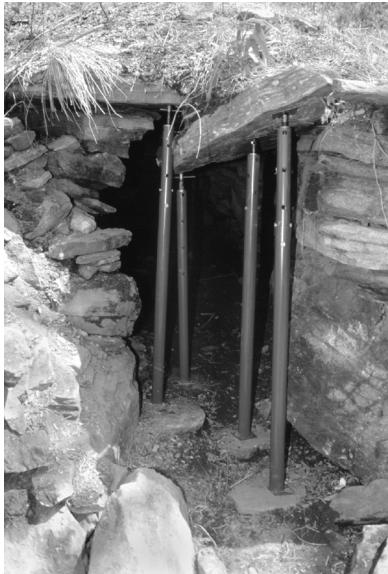
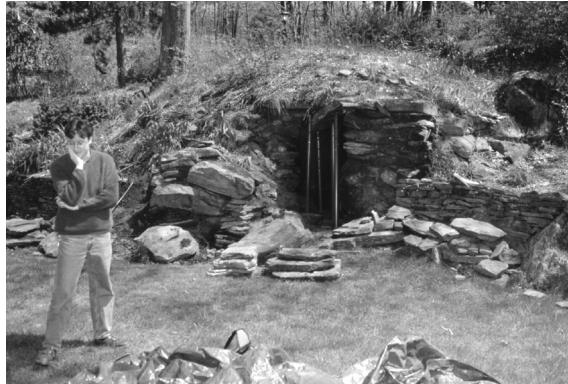
FIGURE 5. TEMPORARY LALLY COLUMNS.

FIGURE 6. WHAT A MESS!

We immediately installed adjustable steel lally columns to stabilize the precarious capstones (FIGURES 5, 6).

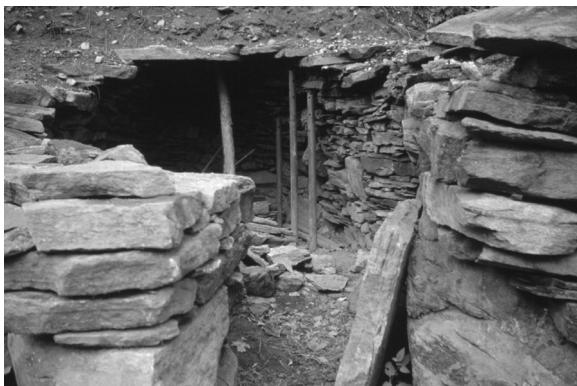
FIGURE 7. CAPSTONES REMOVED.

Before reconstruction could start, we realized that we had to deconstruct further. There were numerous “about to fall” rocks in the upper corbelling. The dirt mound on top was removed with shovels, the cracked capstones were slid off, and unstable sidewall rocks were removed (FIGURE 7). Fortunately, the rear of the chamber and most base rocks were intact.

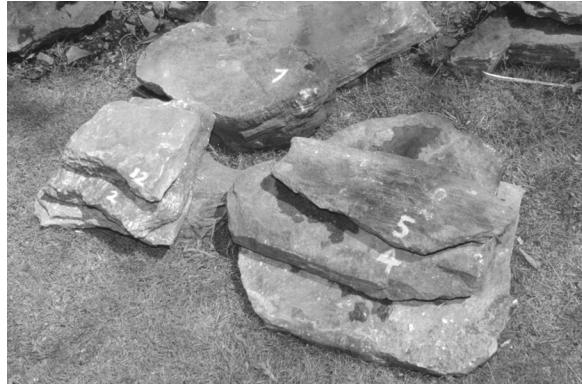
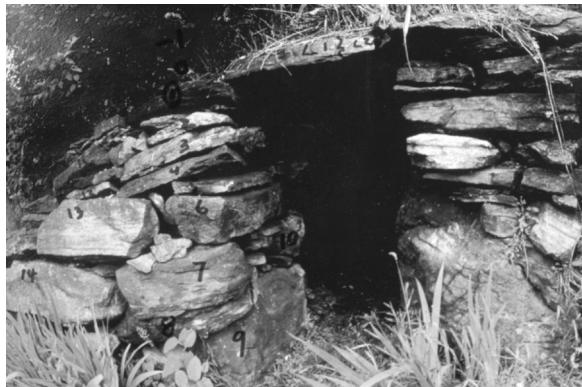
FIGURE 8. CODE NUMBERS PAINTED ON ROCKS.

FIGURE 9. PHOTO ENLARGEMENT WITH CODE NUMBERS SHOWN.

Using existing photo enlargements, we identified the major rocks and coded them with painted numerals (FIGURES 8, 9).

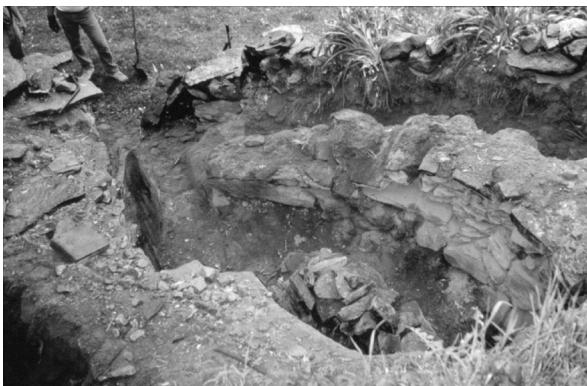
FIGURE 10. PERIMETER ACCESS TRENCH.

An access trench was dug just outside the perimeter, so that the walls could be rebuilt soundly (FIGURE 10).

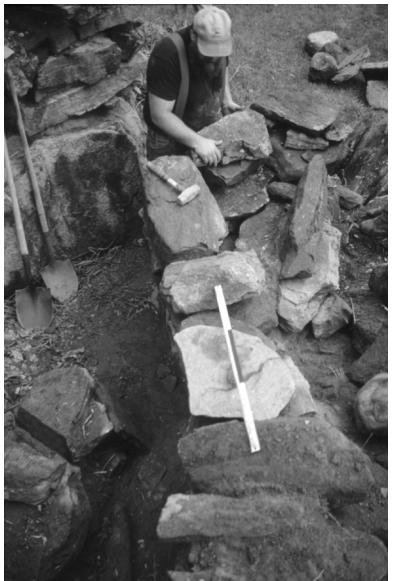
FIGURE 11. RECONSTRUCTION BEGINS.

Rick stressed the importance of chinking, jamming small rock pieces into the cracks between the larger rocks. Soon we were ready to replace the lintel and capstones (**FIGURE 11**).

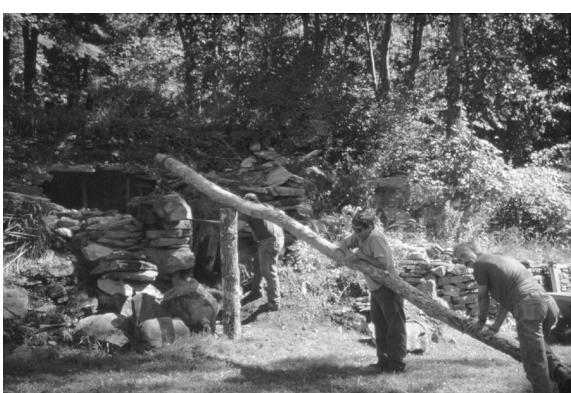
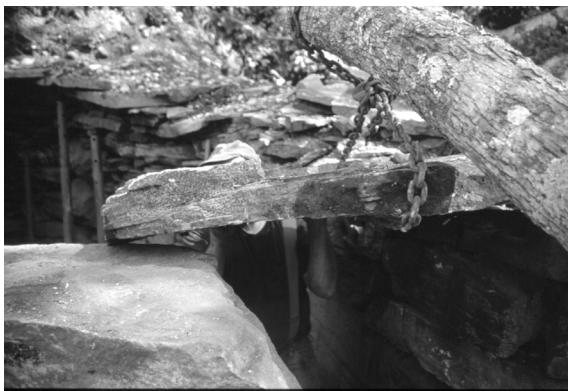
FIGURE 12. 30-FOOT LEVER HOISTS 500 LB. LINTEL.

FIGURE 13. MANEUVERING LINTEL INTO PLACE.

A 30-foot oak tree trunk served as a lever on a 5-foot oak post, which acted as a fulcrum. An iron chain connected the lintel to the end of the lever. Amazingly, with the weight of several people, we easily hoisted the new 500 lb. lintel and gently maneuvered it into place (**FIGURES 12, 13**).

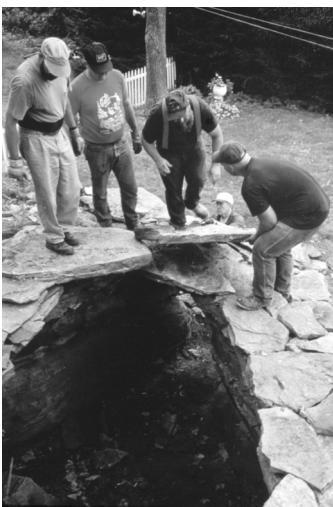
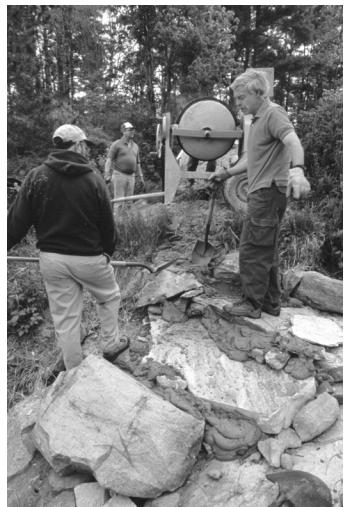
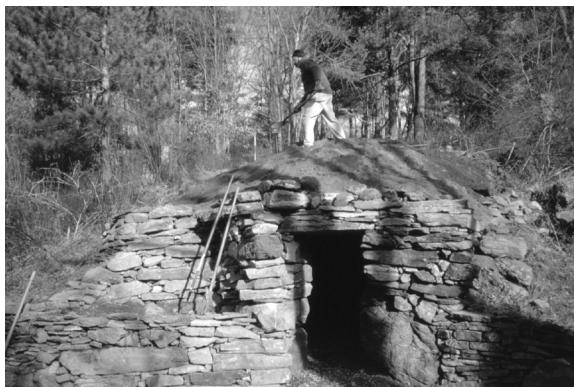
FIGURE 14. REPLACING CAPSTONES.

FIGURE 15. CEMENTING GAPS TO PREVENT WATER SEEPAGE.

FIGURE 16. REPLACING THE DIRT MOUND.

New capstones were carefully placed over the corbelled sidewalls. To prevent future shifting or water seepage, we cemented between some of the capstones, where the mound was certain to conceal it. Then the mound of dirt was replaced and ground cover was planted (**FIGURES 14, 15, 16**).

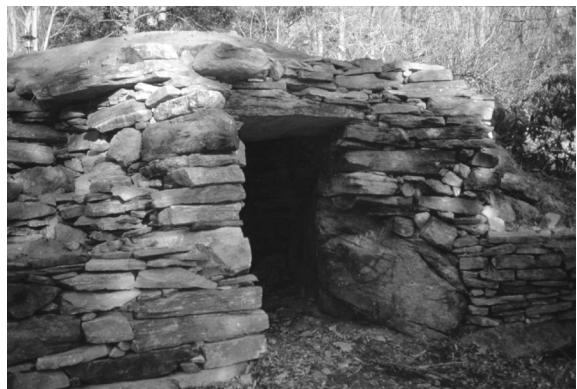
The chamber was now “as good as old” (**FIGURE 17**). The process of planning, getting materials, and organizing volunteer days took about 5 years. The owner was fully appreciative and delighted with the result. So, what started as an embarrassing disaster is now a feather in NEARA’s preservationist cap.

FIGURE 17. “AS GOOD AS OLD”, SPRING 2002.
